The Submarine Division of the Naval Safety Center Presents:

FLASH

Factual Lines About Submarine Hazards

March 2000 – June 2000

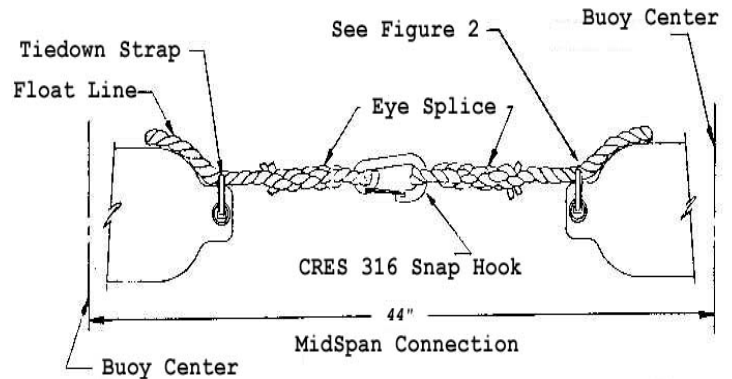
Figure 1

Each buoy shall provide minimum buoyancy of 10 pounds when fully submerged in salt water. The ends of each assembly shall be secured to the forward most and aftermost cleat or chock (if chock is located on the ship centerline). The assembly shall be provided with enough slack so that the line will float clear of the hull. The length (L) of each assembly shall be equal to the distance between the floating lifeline forward and after attachment points (D) multiplied by a factor of 1.05, plus 25 feet; that is $L=(1.05 \times D)+25$. For ease of handling

and stowage, each assembly shall be constructed in segments, which contain no more than 14 buoys each. Segments shall be joined when deployed using the midspan connection show in Figure 1.

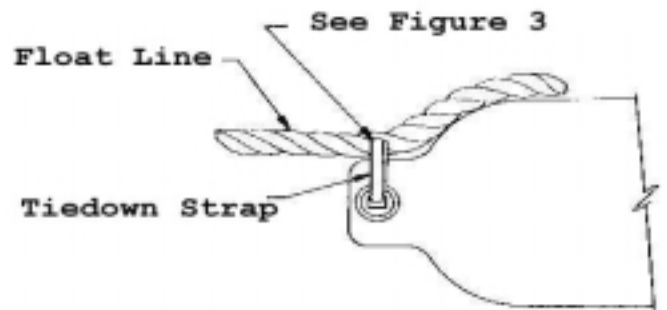
Figure 2

The first buoy at each end of the port and starboard assemblies shall be located where the floating lifeline enters the water. Buoys shall be spaced a maximum of 68 inches on centers, except at the midspan connection where spacing shall be a maximum of 44 inches on centers. Buoy attachment shall be as shown in Figure's 2 and 3.

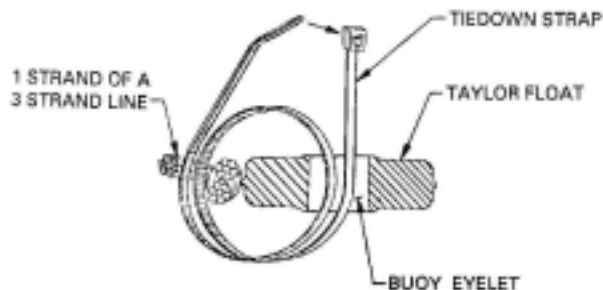
Figure 3

Figure 1 on previous page shows an example of floating lifeline construction. If the straight-line distance between the forward and after attachment points is 200 feet, each assembly is 235 feet $(1.05 \times 200) + 25$. Notice the floats are 68 inches on center except at the midspan connection (Figure 1). There, they are 44 inches on center. In Figure's 2 and 3, you can see how to wrap the tie down strap around two

strands of the floating line. Feed it through the line twice.

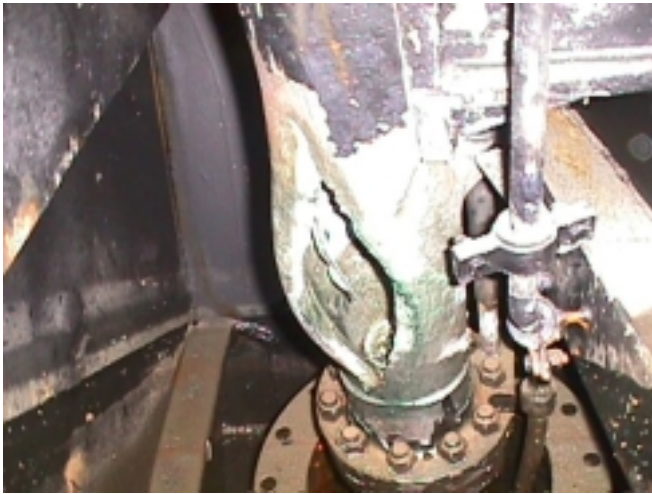
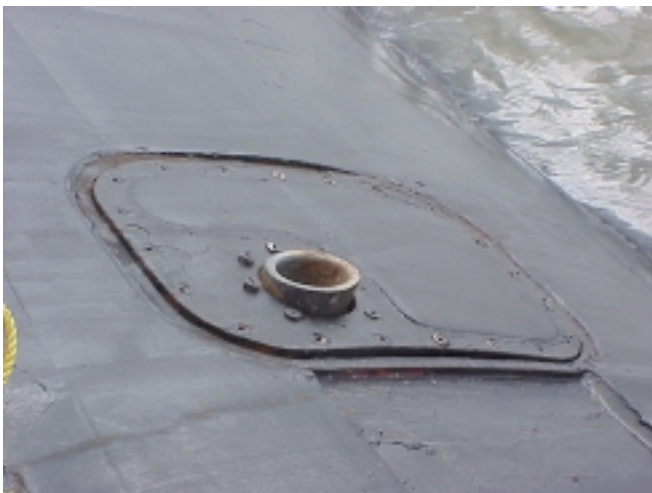
A unit in the Atlantic fleet had an explosive mishap causing major damage to the forward signal ejector. The ship was at test depth, preparing to hand-ram a combination flare from the forward signal ejector. While flooding and equalizing the signal ejector, the device detonated with enough force to be felt through out the ship. Surprised? Consider this.

The 12 bolts attaching the muzzle ball-valve assembly to the barrel sheared. The fairing over the muzzle ball-valve assembly was bowed outward away from the pressure hull. The barrel was split open. The gasket on the breech failed and allowed sea water to enter the bow compartment with the ship at test depth. All of this from a pyrotechnic!

The MK-120 Mod 1. Green Combination Flare

Fortunately there were no injuries as a result of this mishap. The ship immediately proceeded shallow, surfaced and returned to port.

Because of the mishap, **NALC L259, Mk-120 Mod 0, Lot number CRA89B001M001A** has been reclassified to condition code **J** by **NAR 0419-00** and **Lot number CRA89B001M001B** has been reclassified to condition code **J** by **NAR 0420-00** also.

COMSUBPAC released a joint message 032207Z Apr 00, to **suspend ALL use of the MK-120 until further notice.**
